NOTE: SEE PLATE 7-7 FOR CHANNEL AND WATERSHED LOCATIONS. PROFILE DESCRIPTIONS REPRESENT PRE-MINING CONDITIONS. SEE APPENDIX 7-H FOR PHOTOS AND CHANNEL DESCRIPTIONS.

CO-OP MINING CO.		
HUNTINGTON, UTAH		
POST-MINING DRAINAGE PROFILES		
SCALE: As Shown	DRAWN BY: C. Reynolds	DATE: 4/20/94
BEAR CANYON		PLATE 7-8C

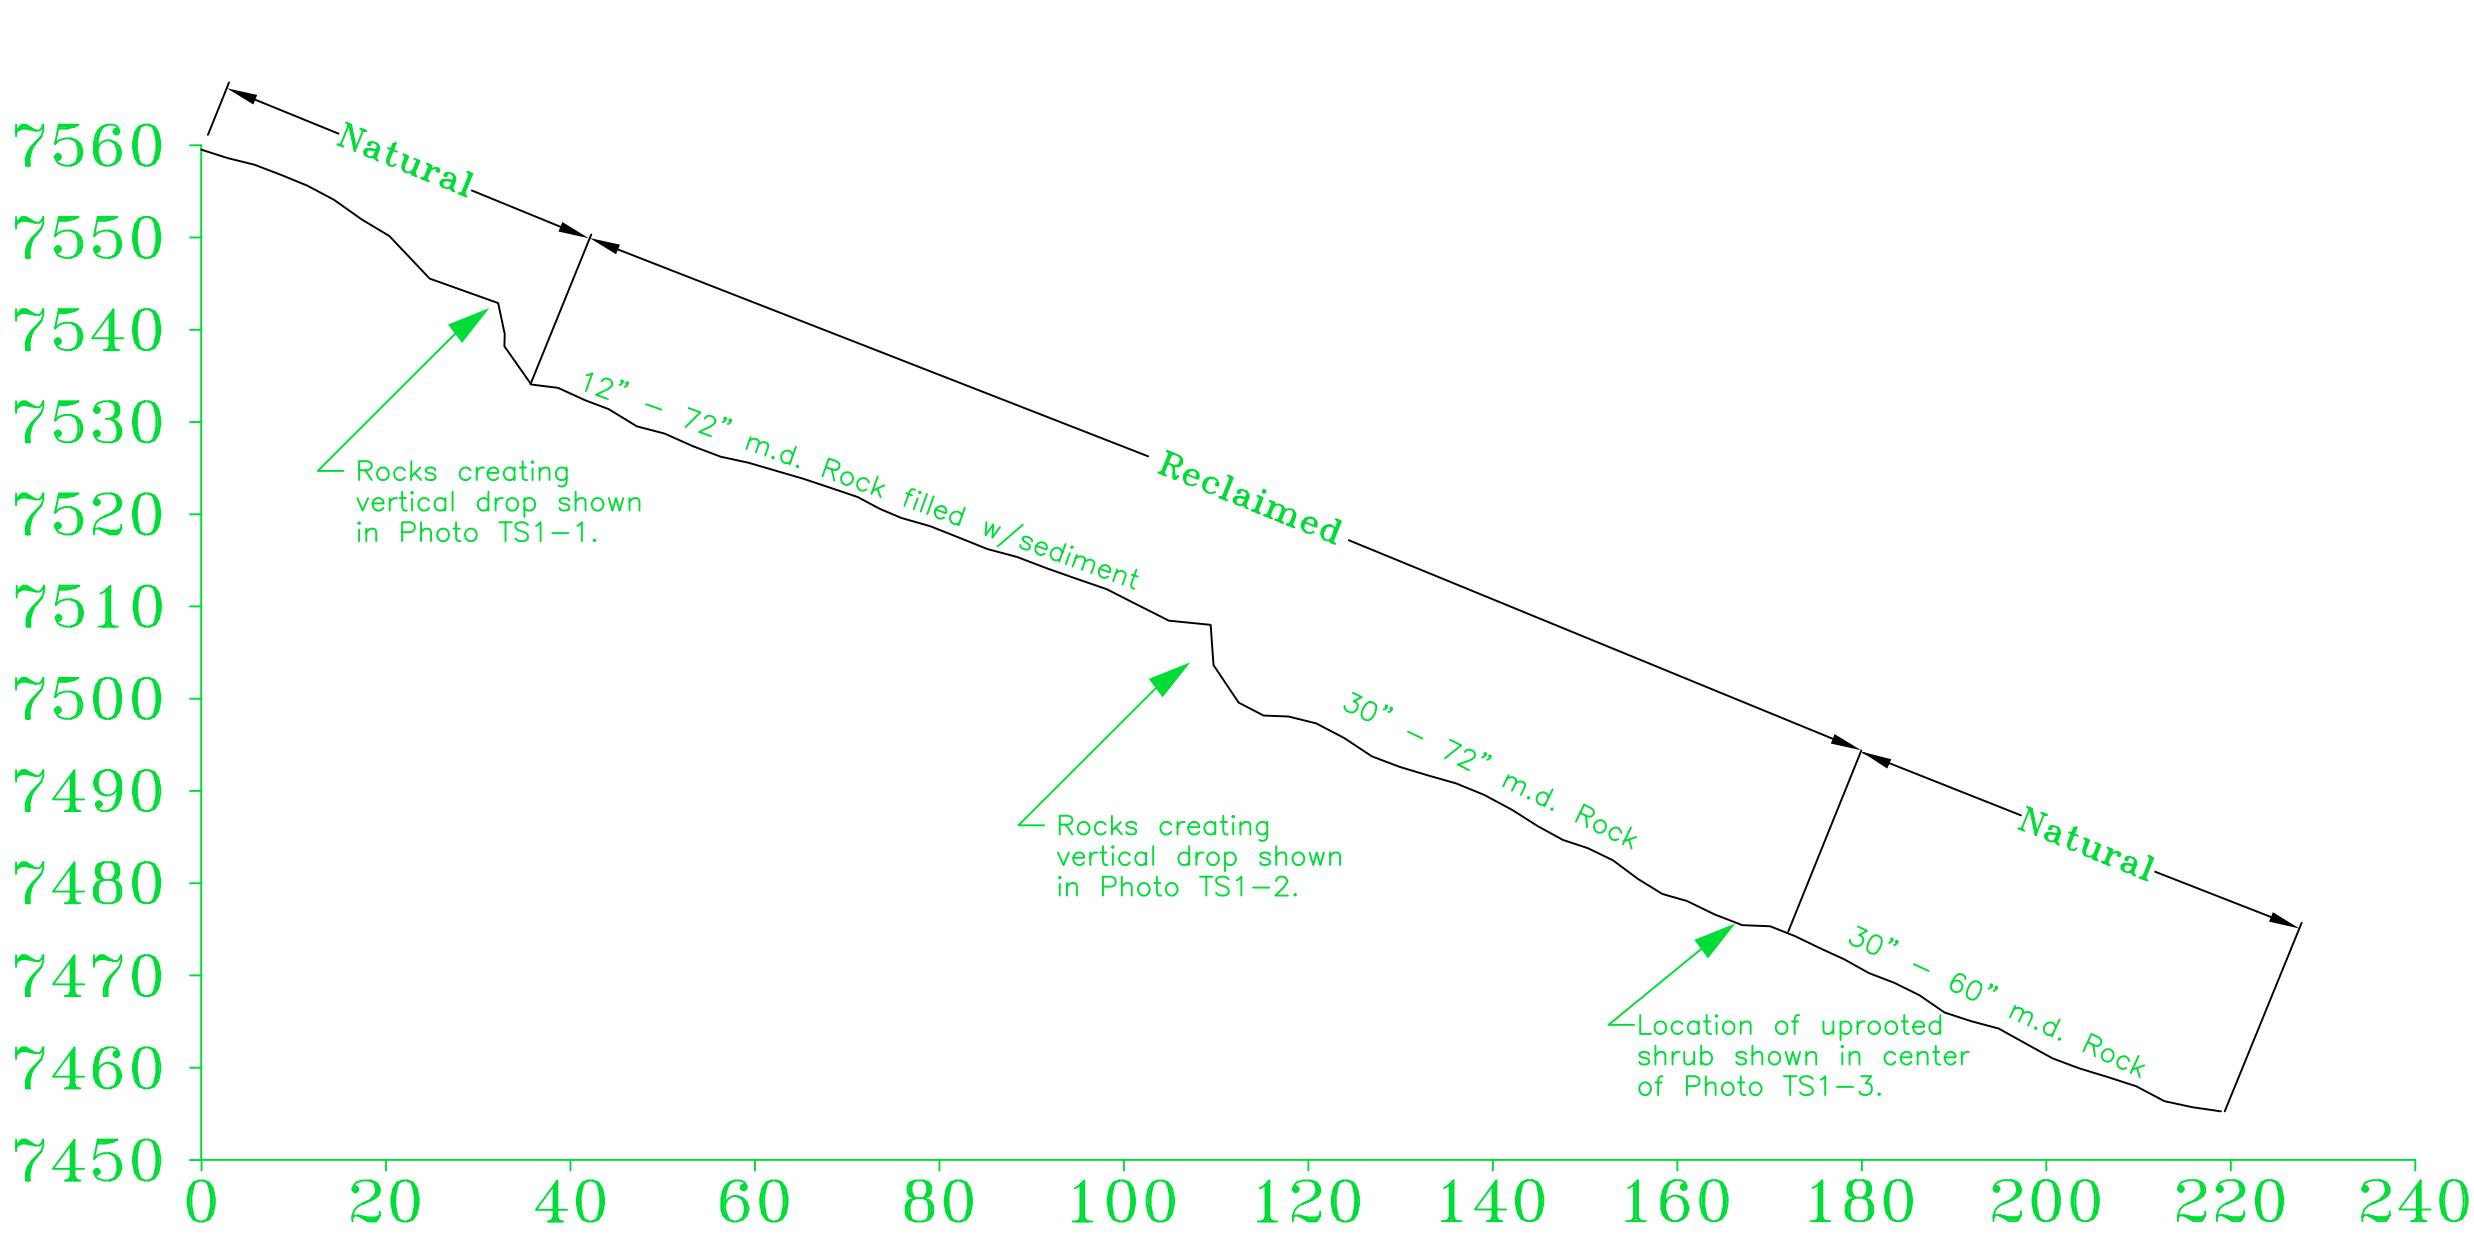
PROFILE CHANNEL RC-TS1 (WATERSHED WS-1 partial)

SEE APPENDIX 7-H, PG 53 FOR CHANNEL DESCRIPTION

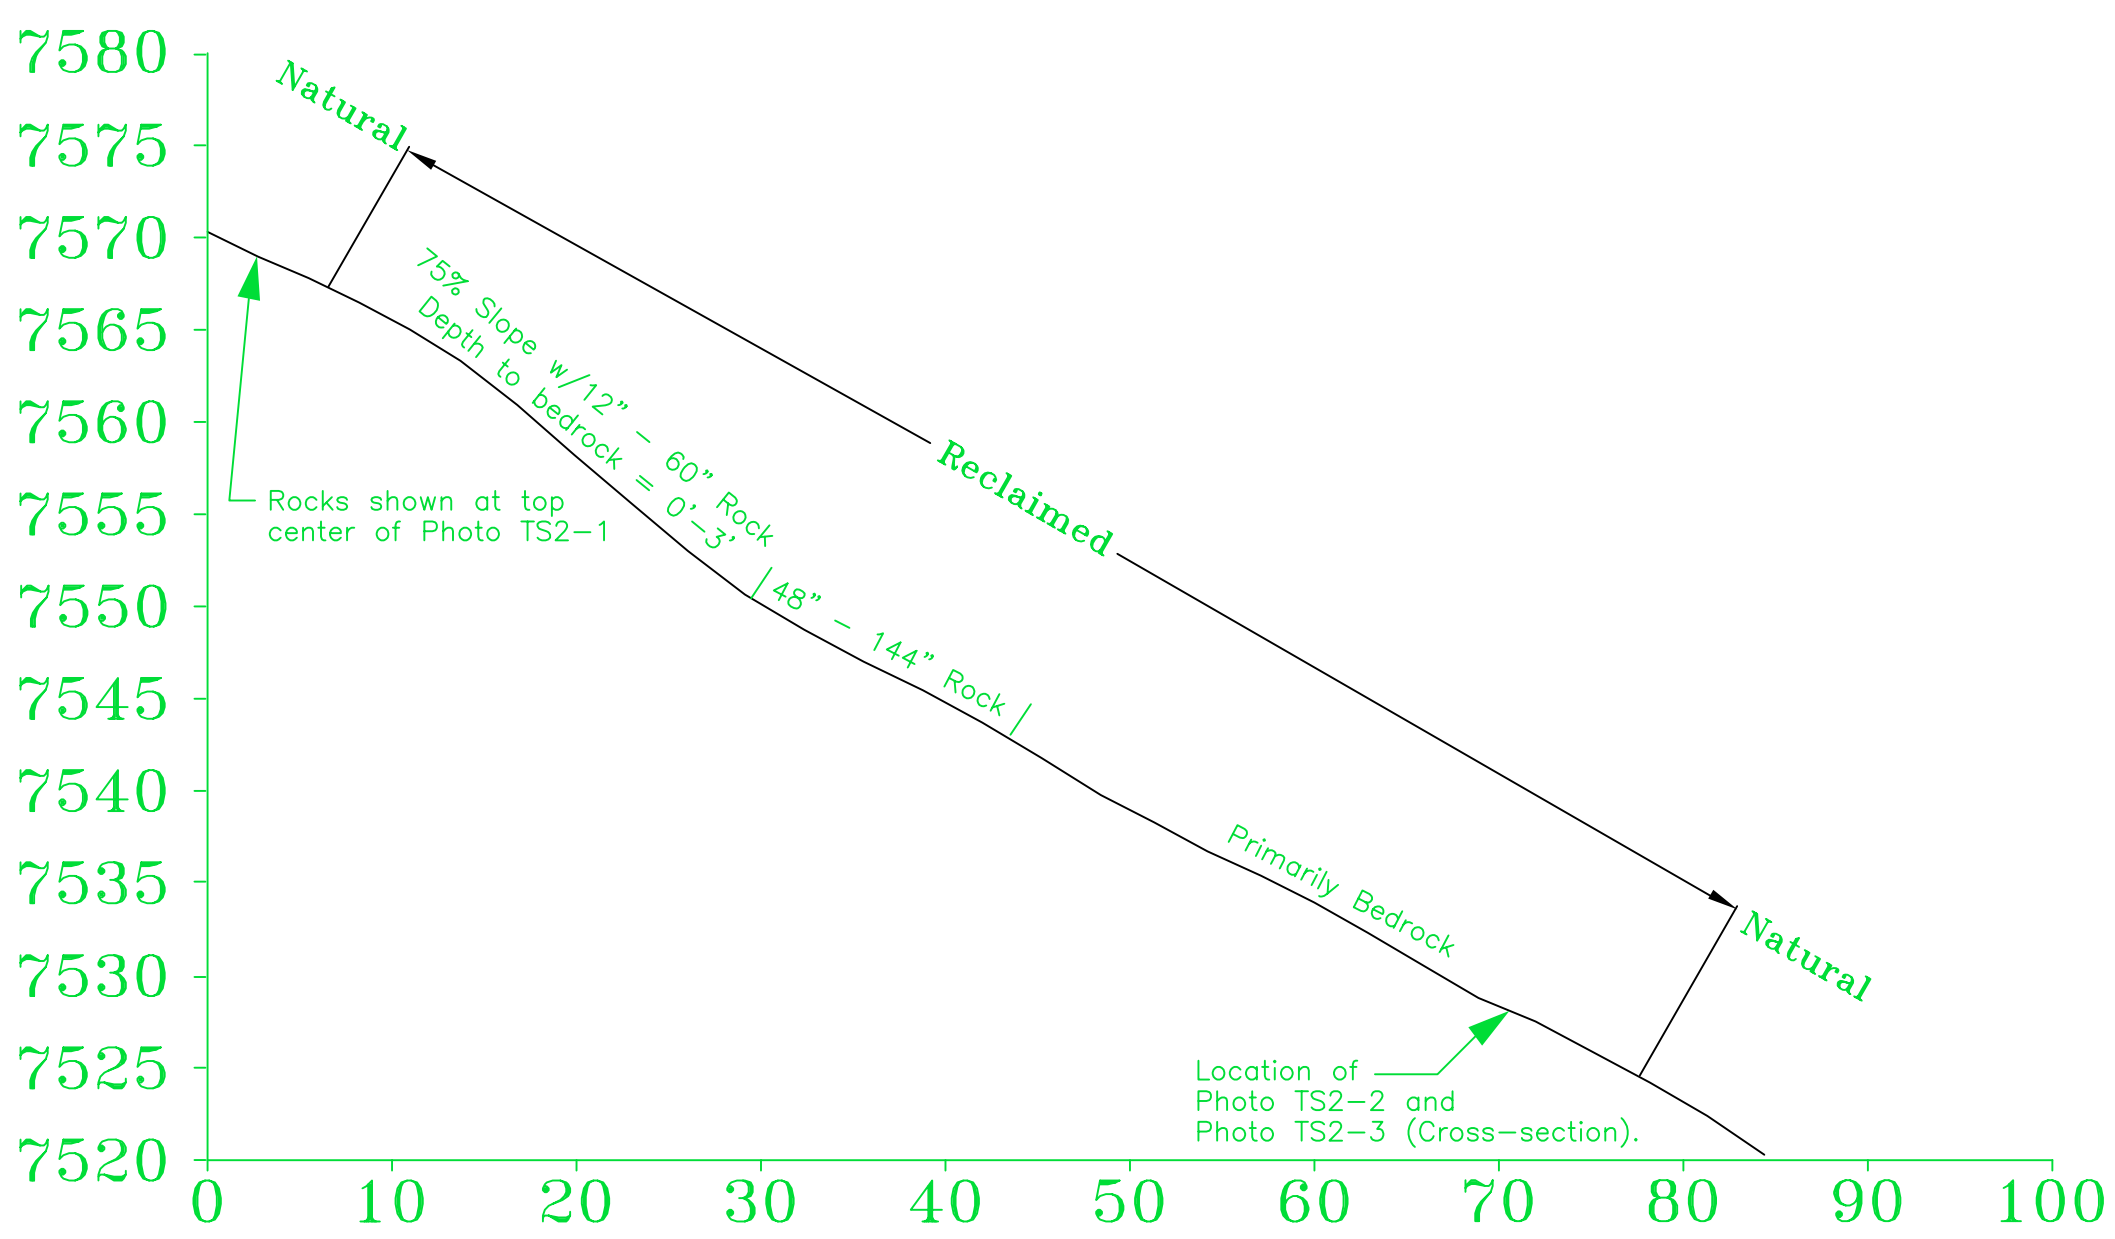
PROFILE CHANNEL RC-TS2 (WATERSHED WS-1 partial)

SEE APPENDIX 7-H, PG 55 FOR CHANNEL DESCRIPTION

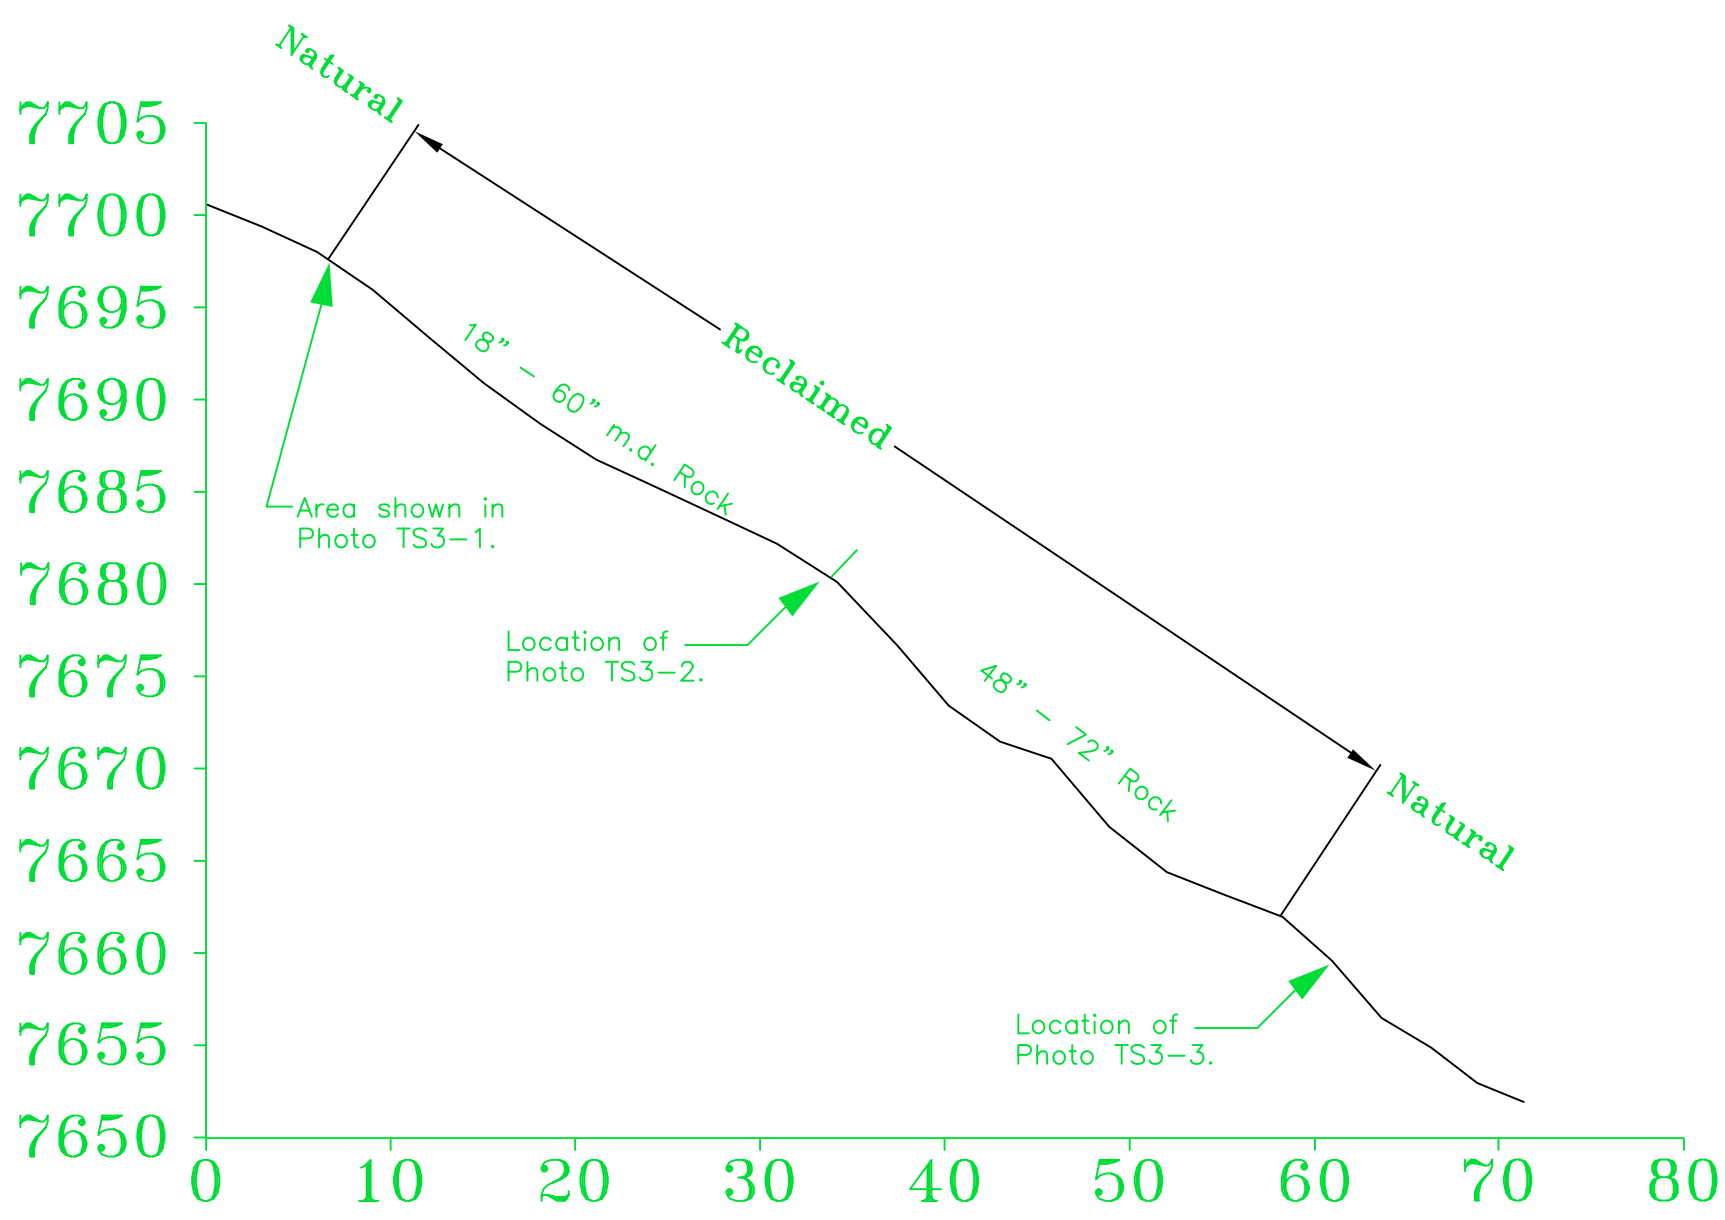
PROFILE CHANNEL RC-TS3 (WATERSHED WS-1 partial)

SEE APPENDIX 7-H, PG 57 FOR CHANNEL DESCRIPTION

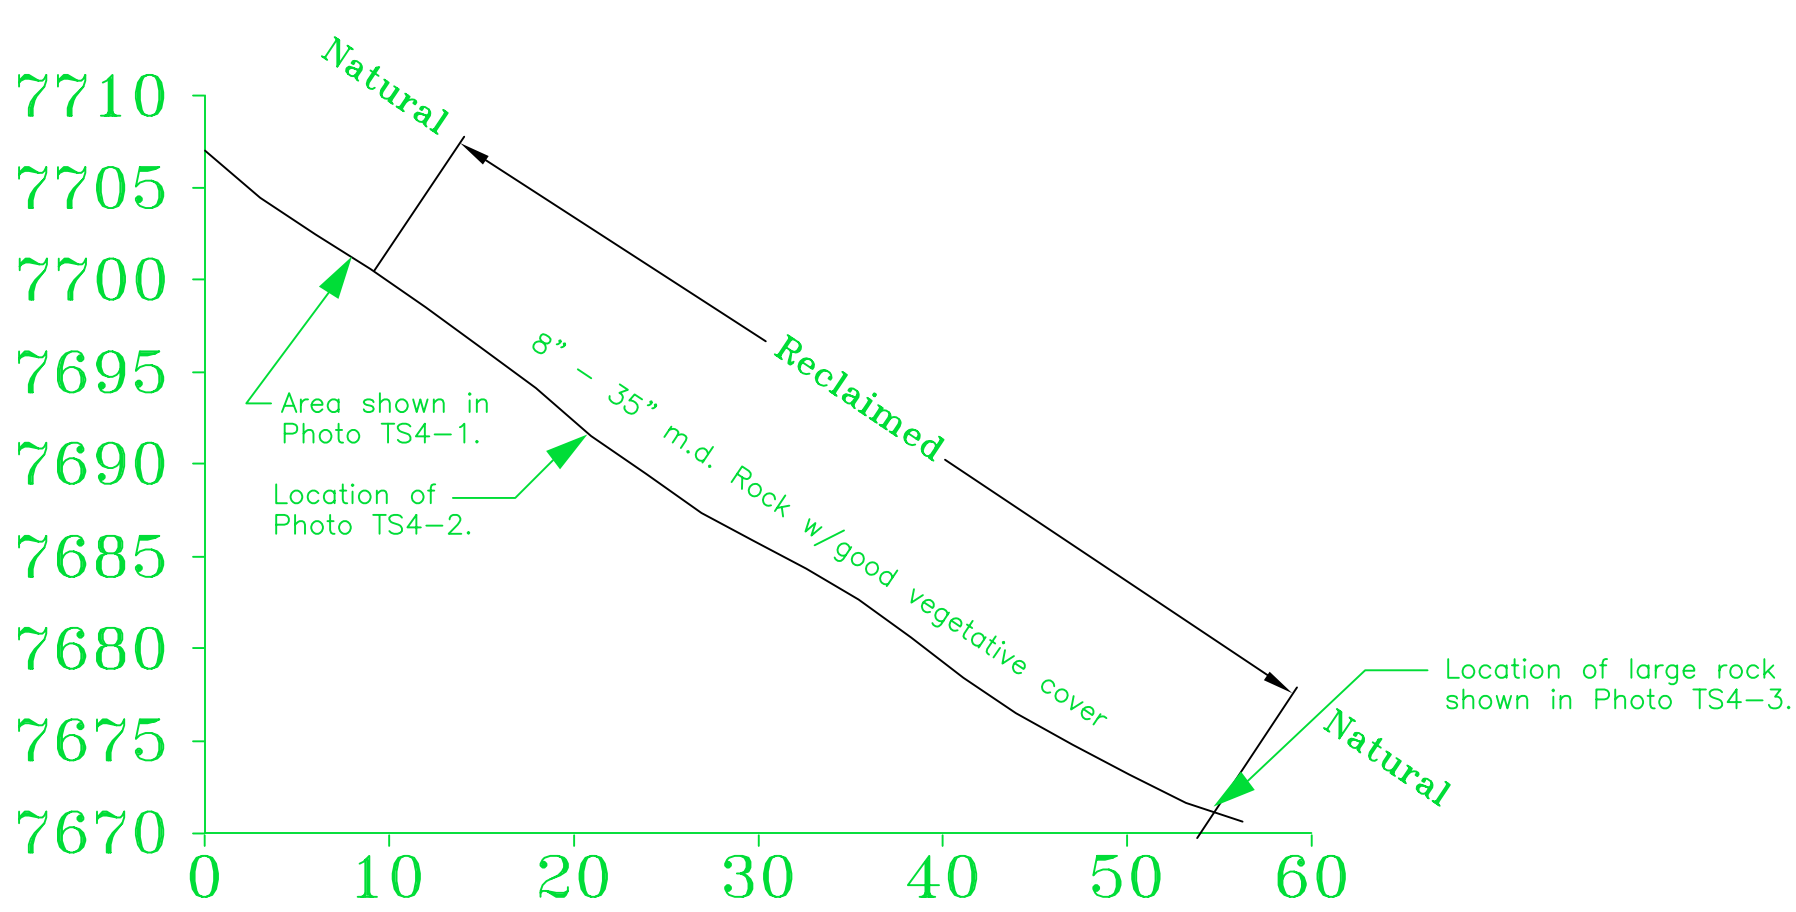
PROFILE CHANNEL RC-TS4 (WATERSHED WS-1 partial)

SEE APPENDIX 7-H, PG 59 FOR CHANNEL DESCRIPTION

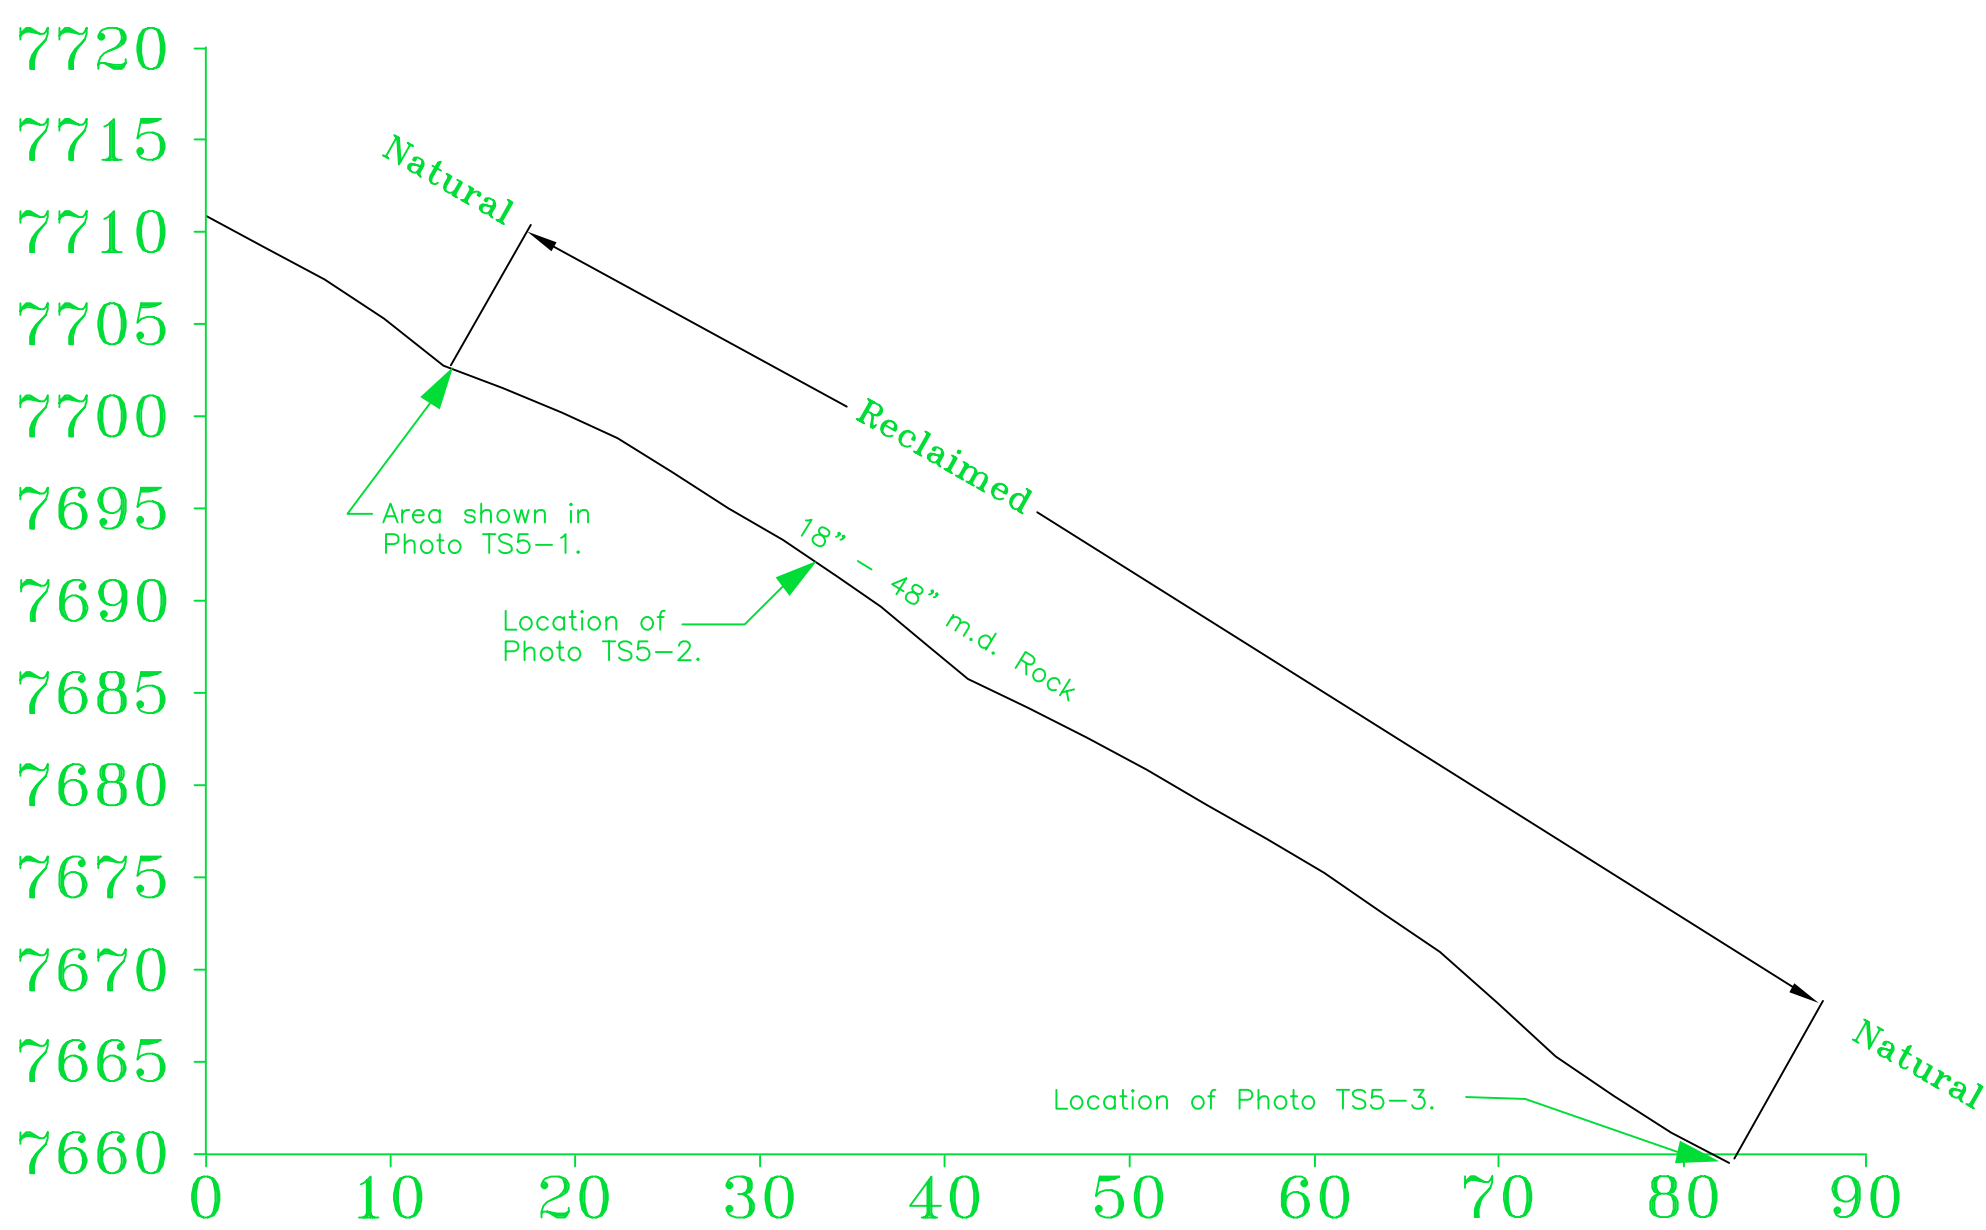
PROFILE CHANNEL RC-TS5 (WATERSHED WS-1 partial)

SEE APPENDIX 7-H, PG 61 FOR CHANNEL DESCRIPTION

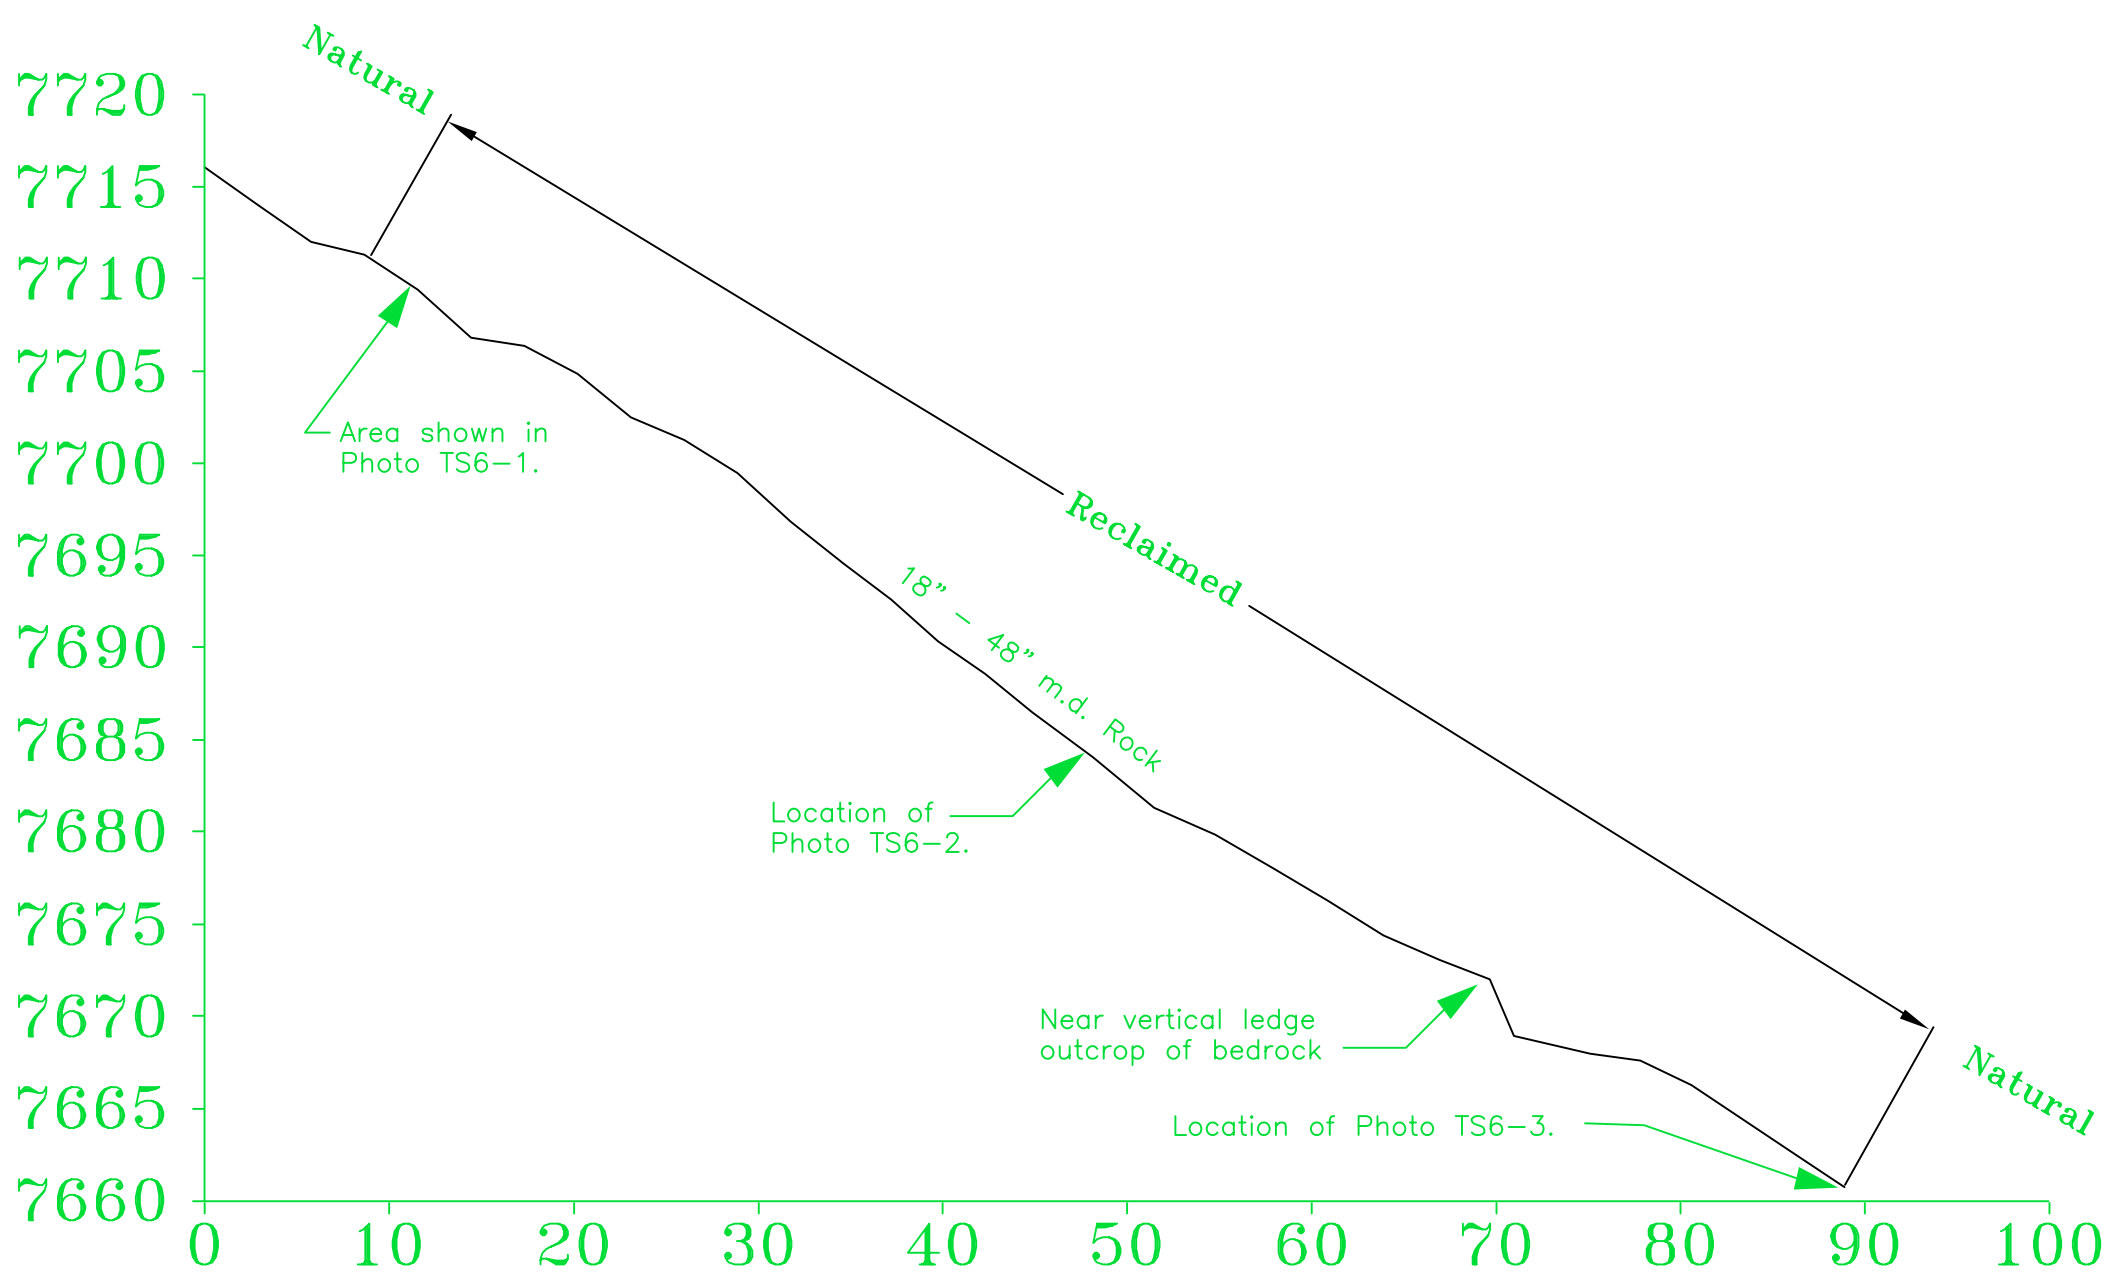
PROFILE CHANNEL RC-TS6 (WATERSHED WS-1 partial)

SEE APPENDIX 7-H, PG 63 FOR CHANNEL DESCRIPTION
